Civic Theatre Seismic Strengtheni

HOLMES CONSULTING GROUP

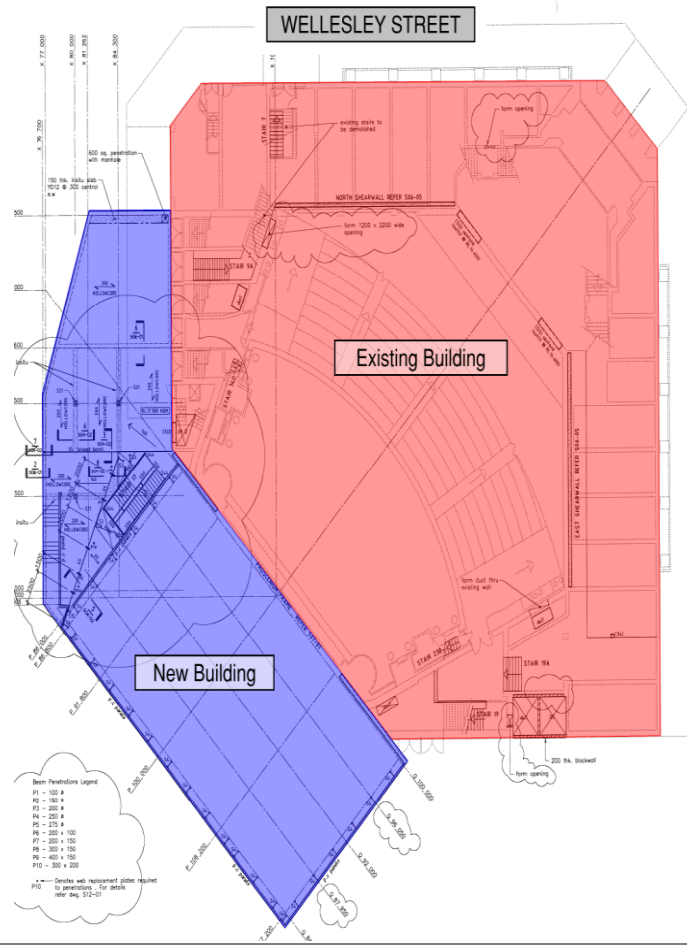
Extent of Work

Extent of existing building and new building indicated

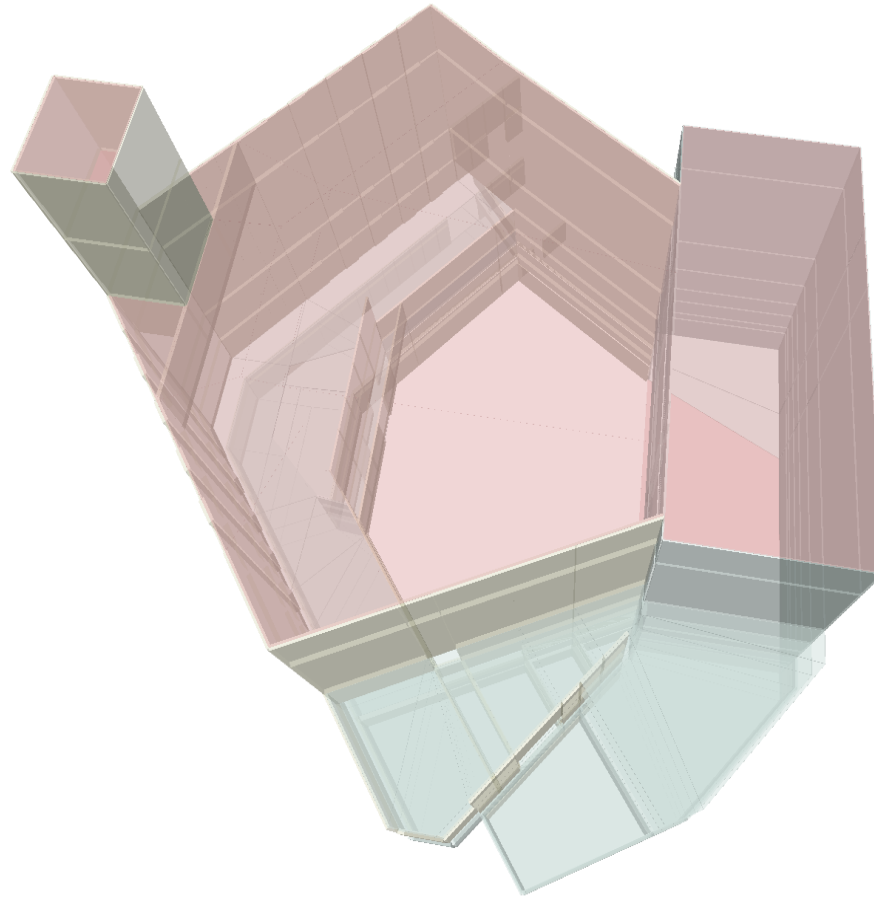
Structural Analysis

Non Linear Time
History Analysis
computer model

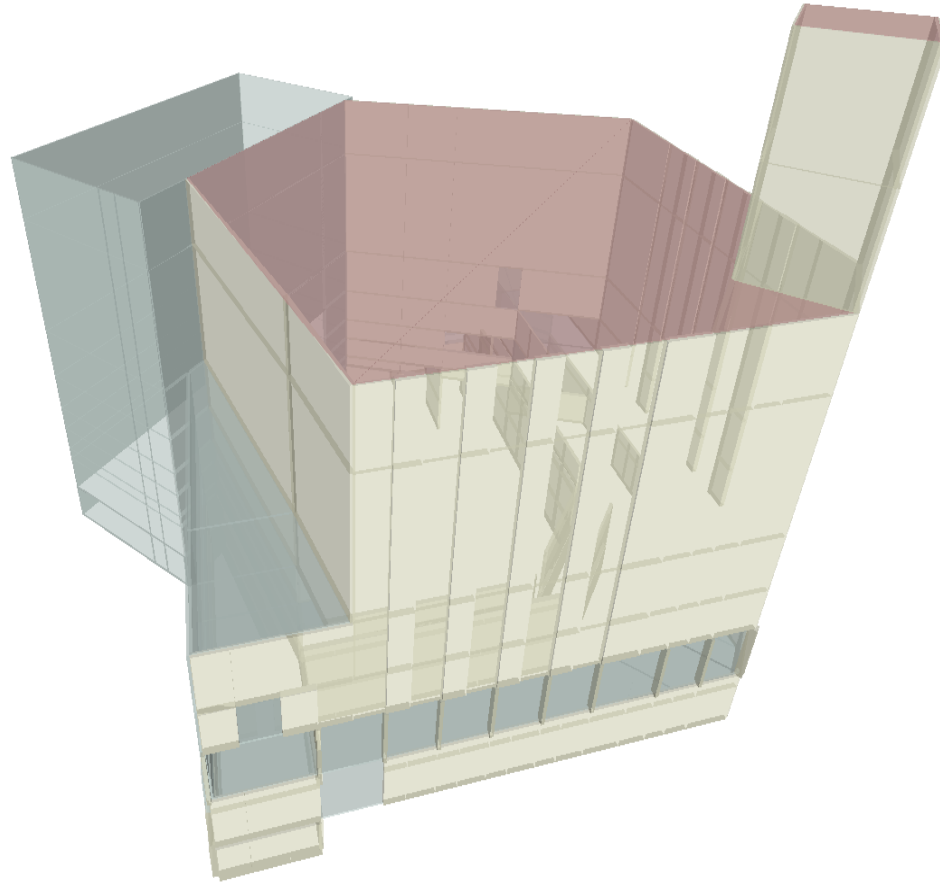
Structural Analysis

Non Linear Time
History Analysis
computer model

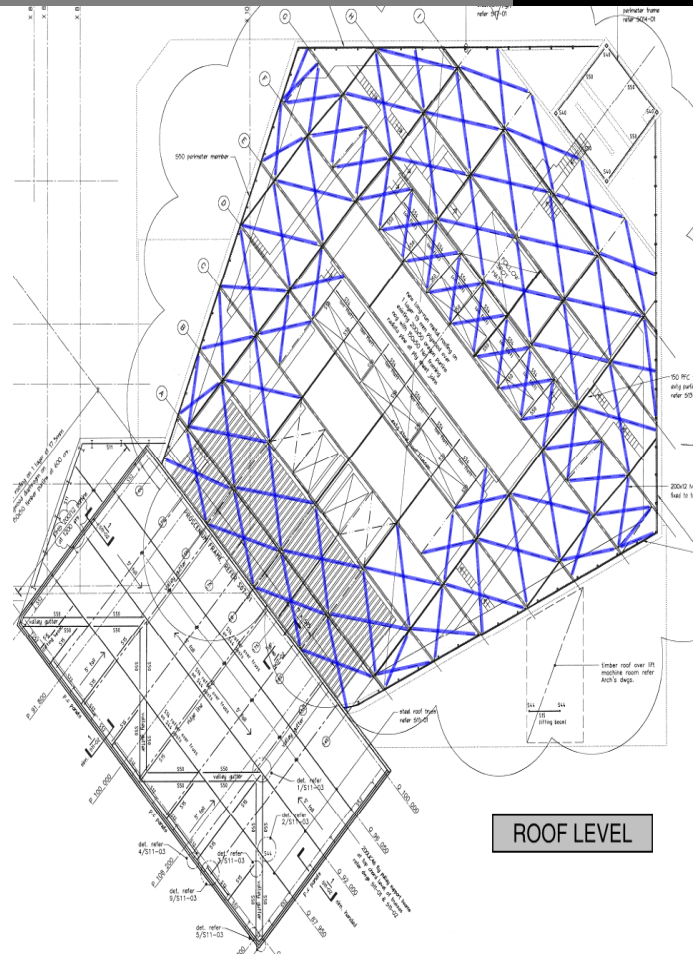
ROOF LEVEL

Lateral Load Resistance

New steel rod bracing at roof level to brace the top of the masonry walls

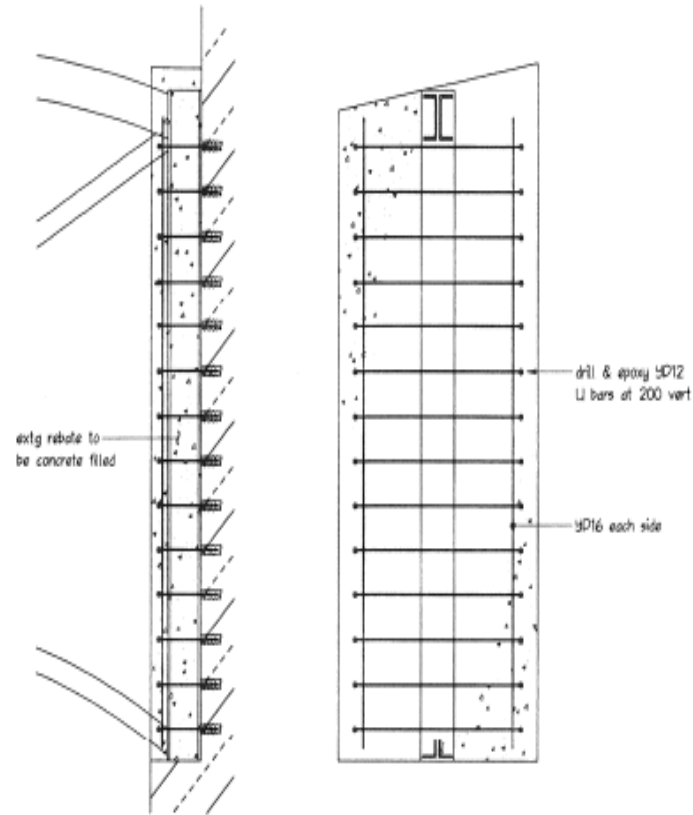
1 auditorium roof truss end connection reinforcing

Lateral Load Resistance

Truss end connection to brickwork strengthening

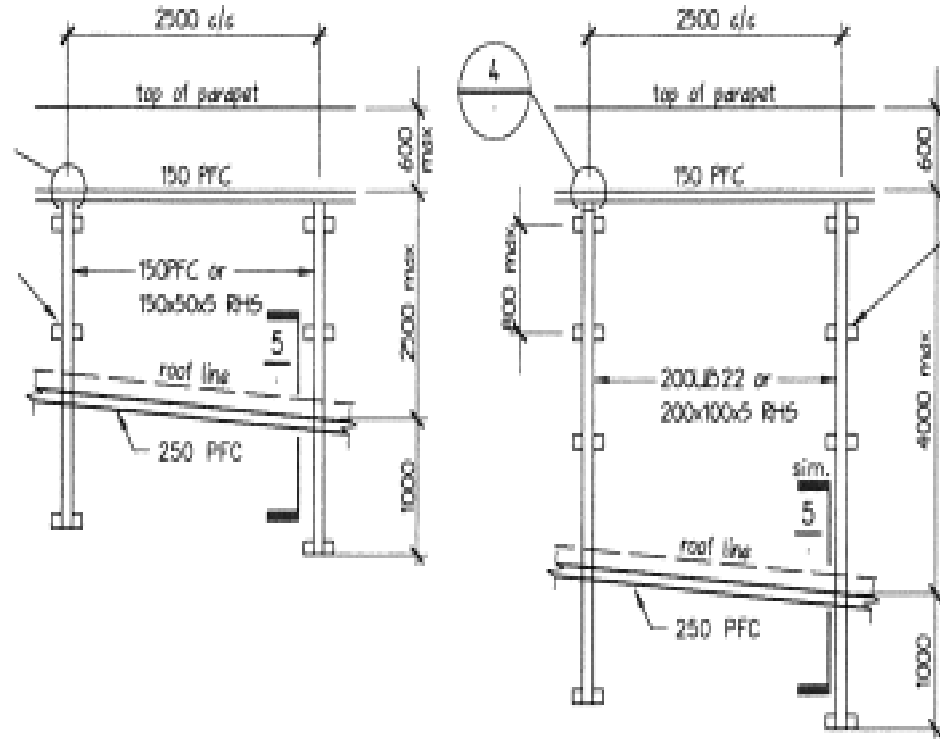
1 parapet strengthening

Lateral Load Resistance

Parapet bracing details

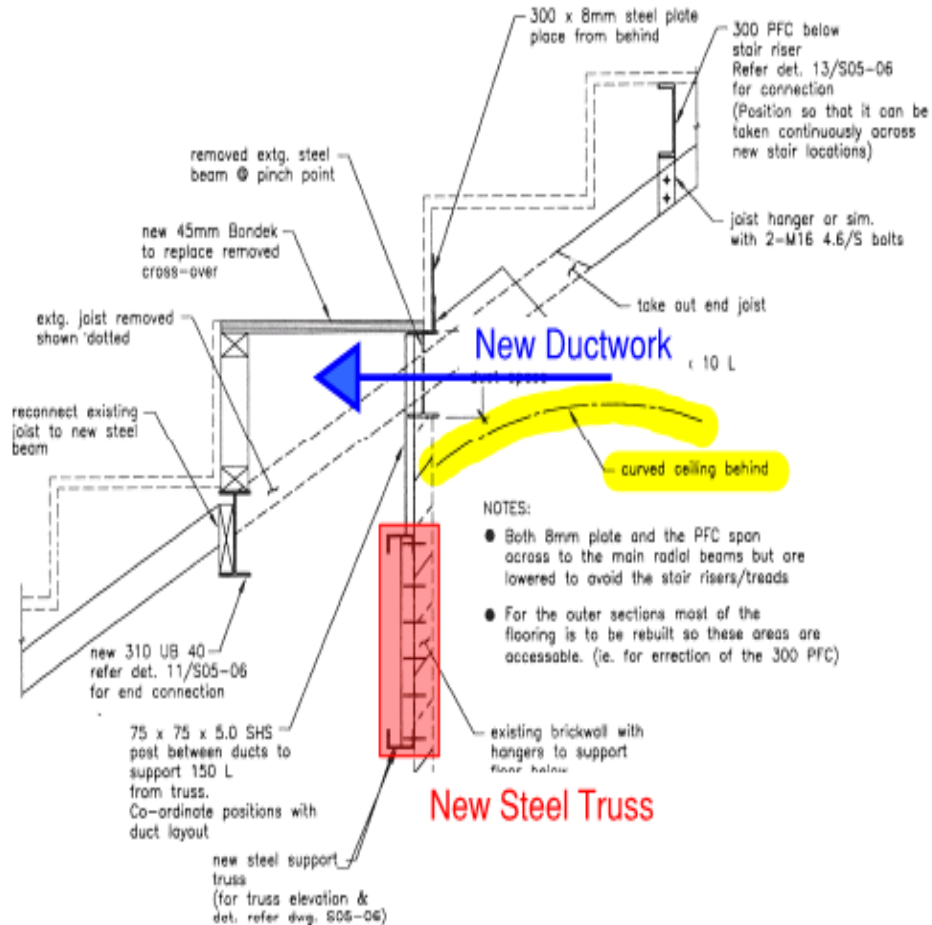
Structural Gymnastics

Removing an existing steel beam to create room for new ductwork to the auditorium

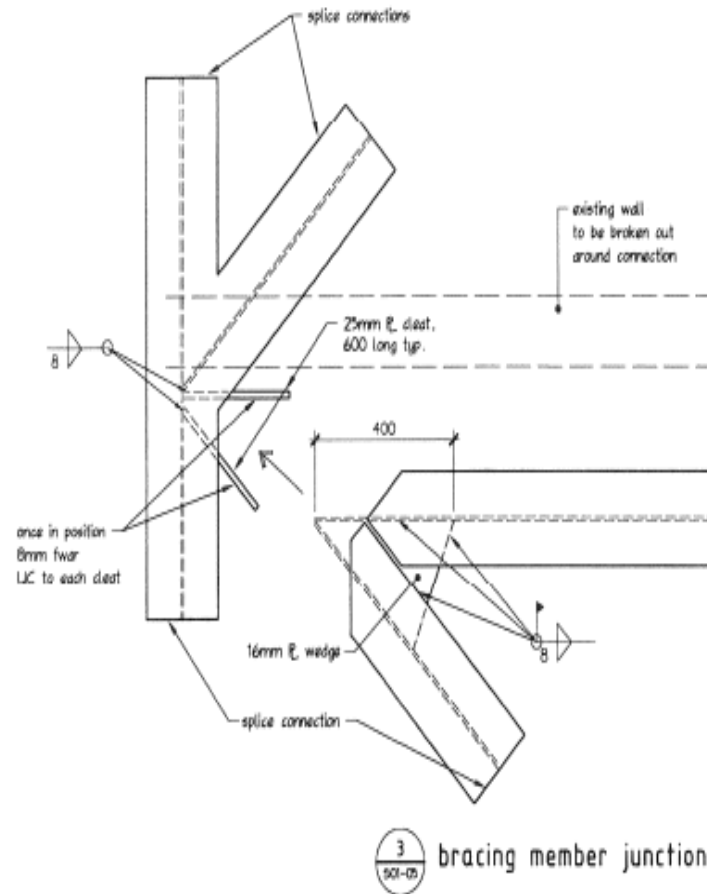
Structural Gymnastics

Specific connection detailing to enable construction around existing structure

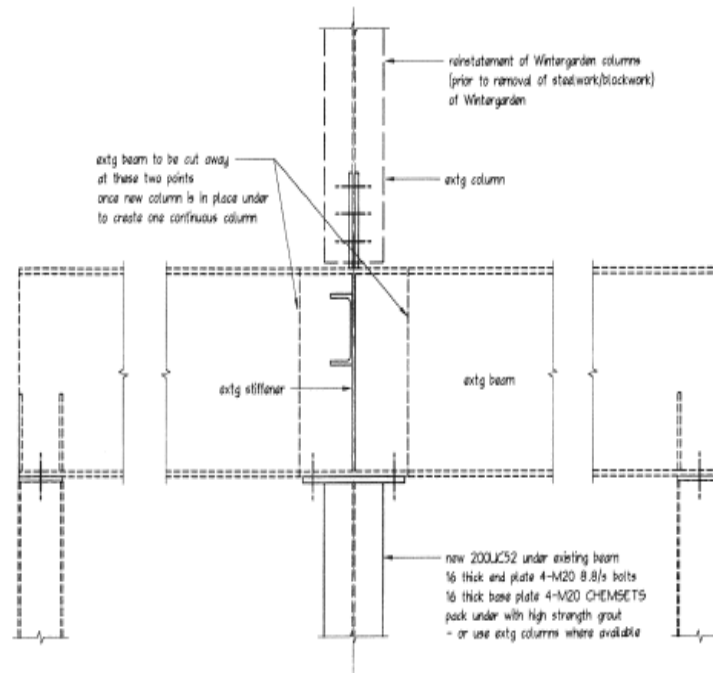
reinstatement of Wintergarden columns

Deconstruction Sequencing

Reinstatement of the existing Wintergarden columns

scale 1:10

Alternatively provide temporary props to existing beam and retain until the stalls floor framing has been removed. Replace new column at a level to suit the regraded primary steelwork of the existing stalls. Provide new timber framing and flooring for stalls to suit new profile - Refer Architect.
