Civic Theatre Restoration & Strengthening

Mark Hedley
Senior Engineer
Downer NZ Ltd

Constructed 1929

Re-Furbished 1999

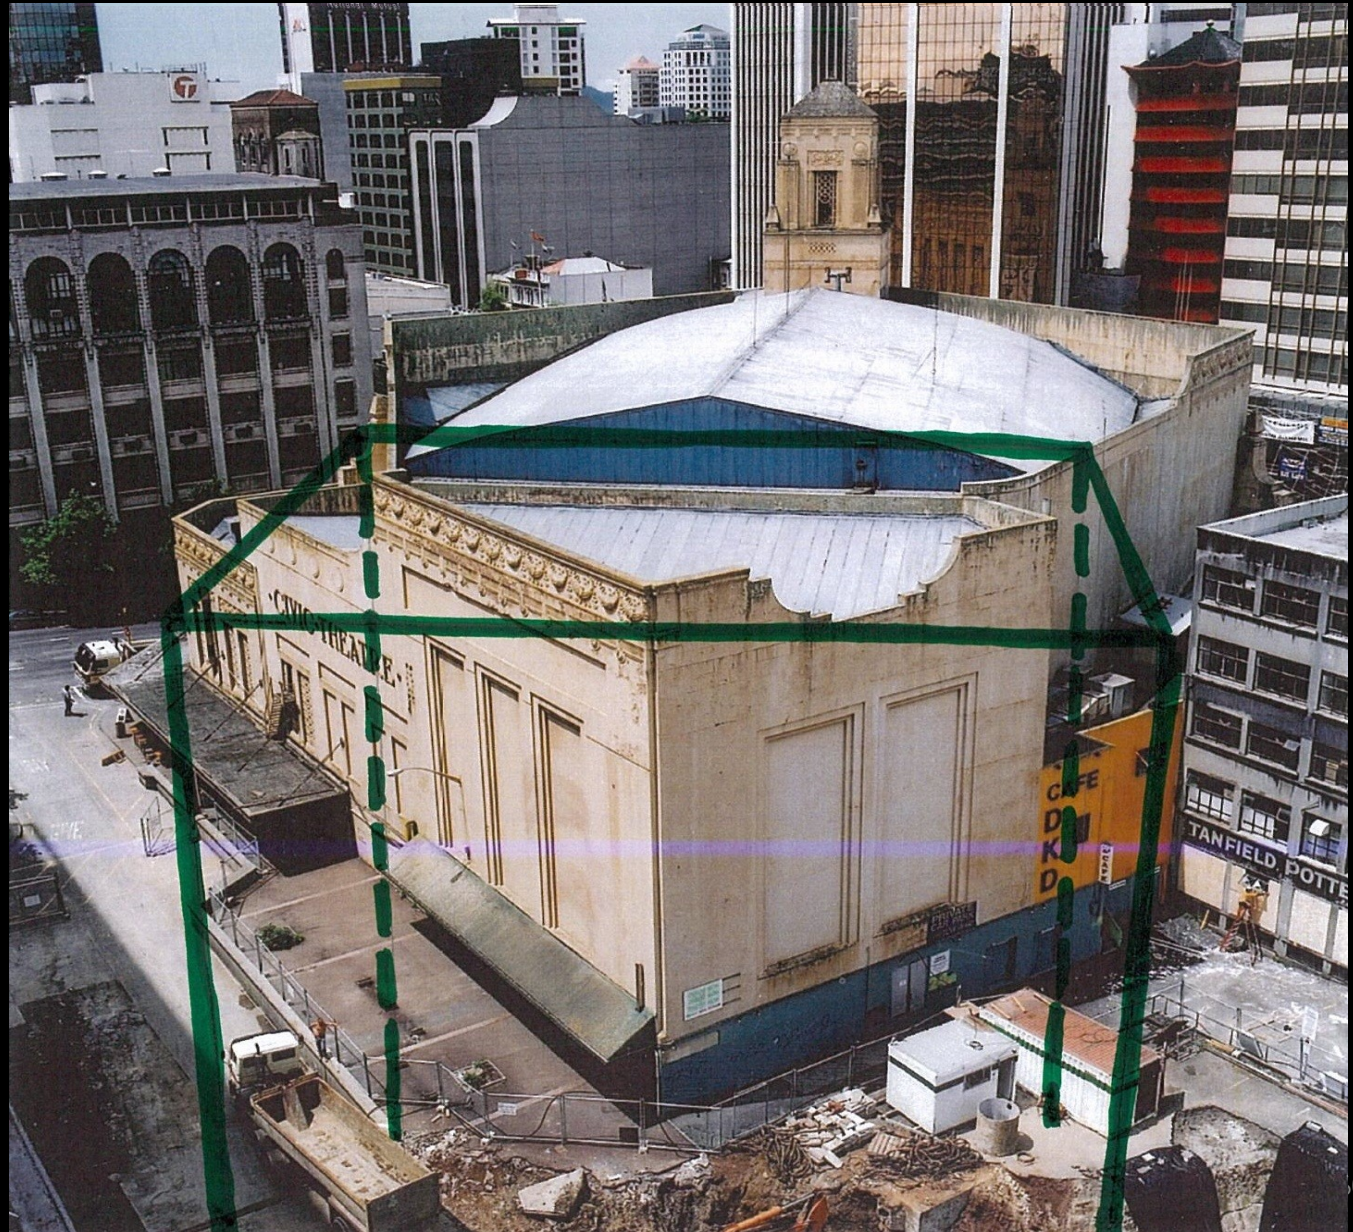
New Fly Tower

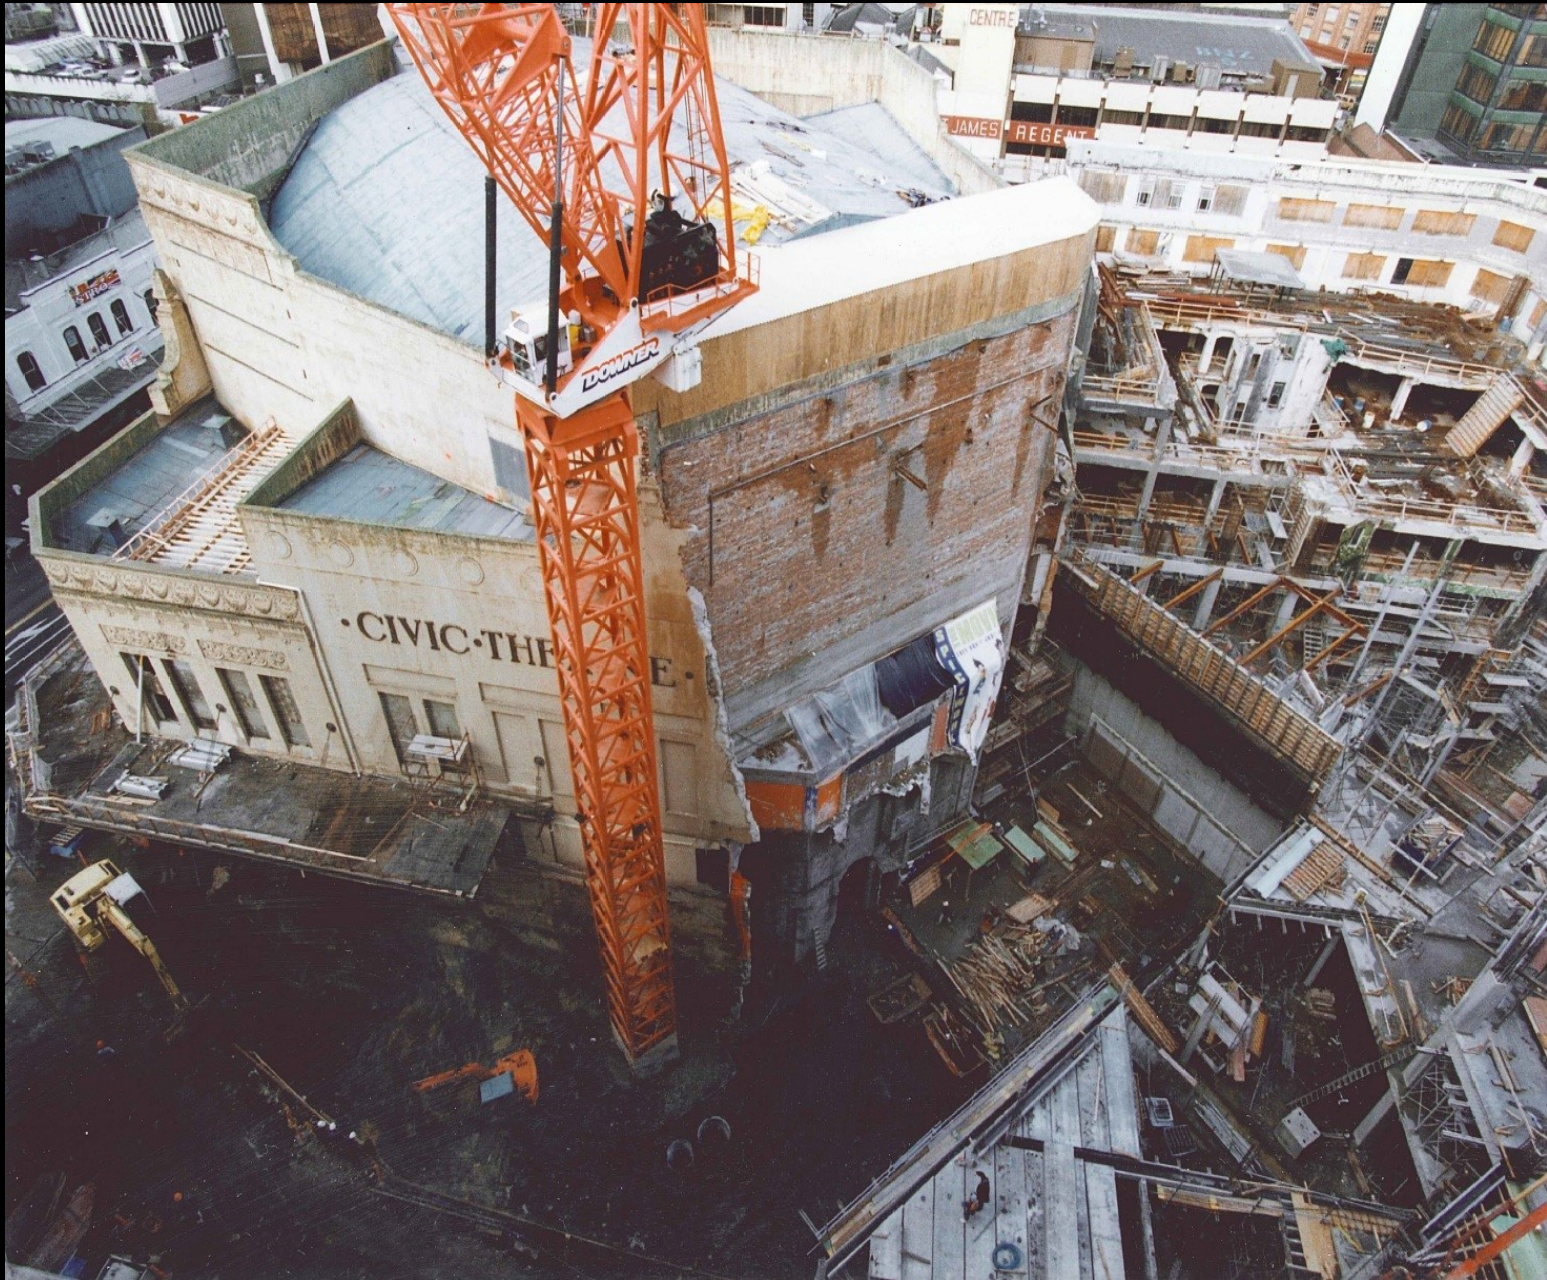
Old Fly Tower removed

Existing Brick Proscenium wall to be replaced by new reinforced concrete wall

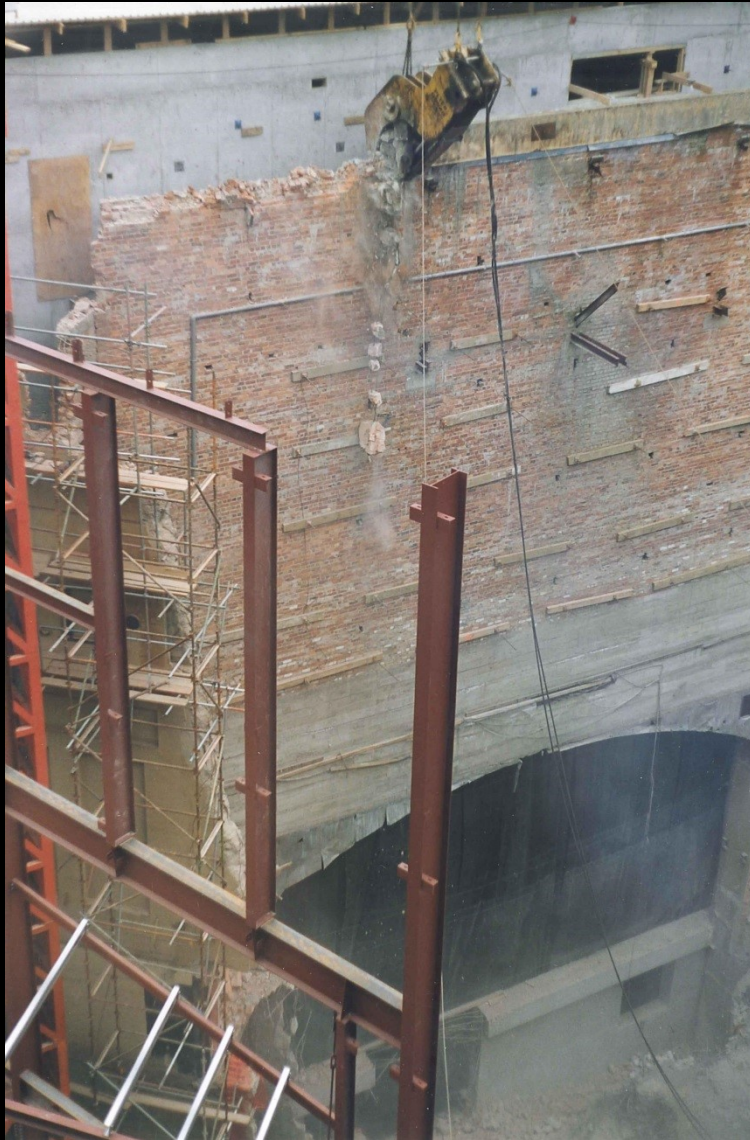
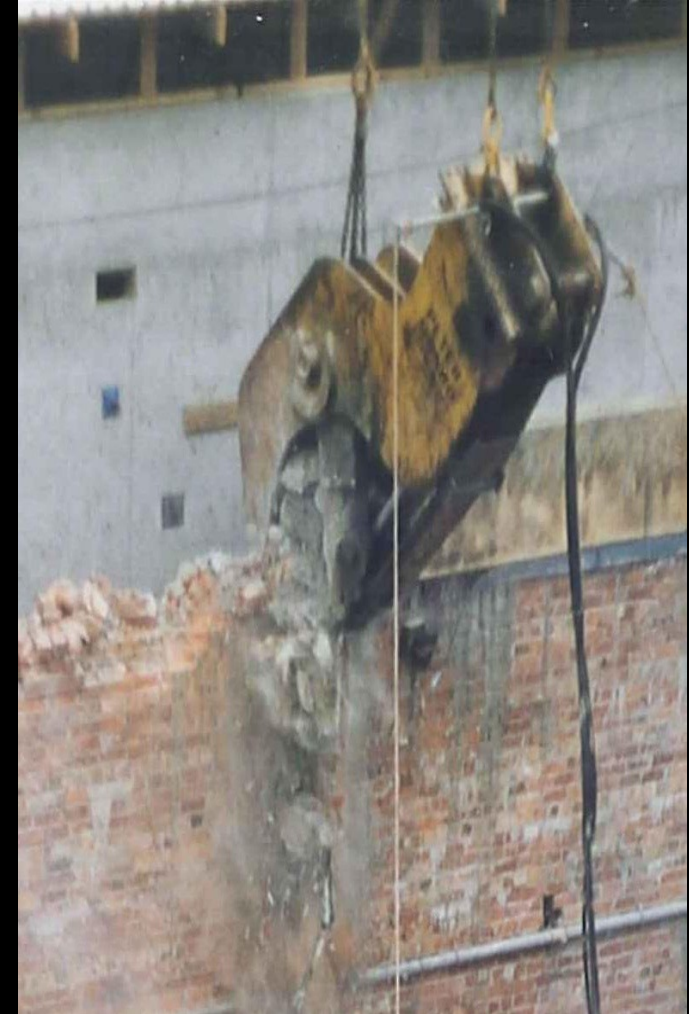
*Proscenium wall
de-construction*

*New reinforced
concrete wall
complete
(behind brick
wall)*

*New Fly-Tower
steel framing
underway*

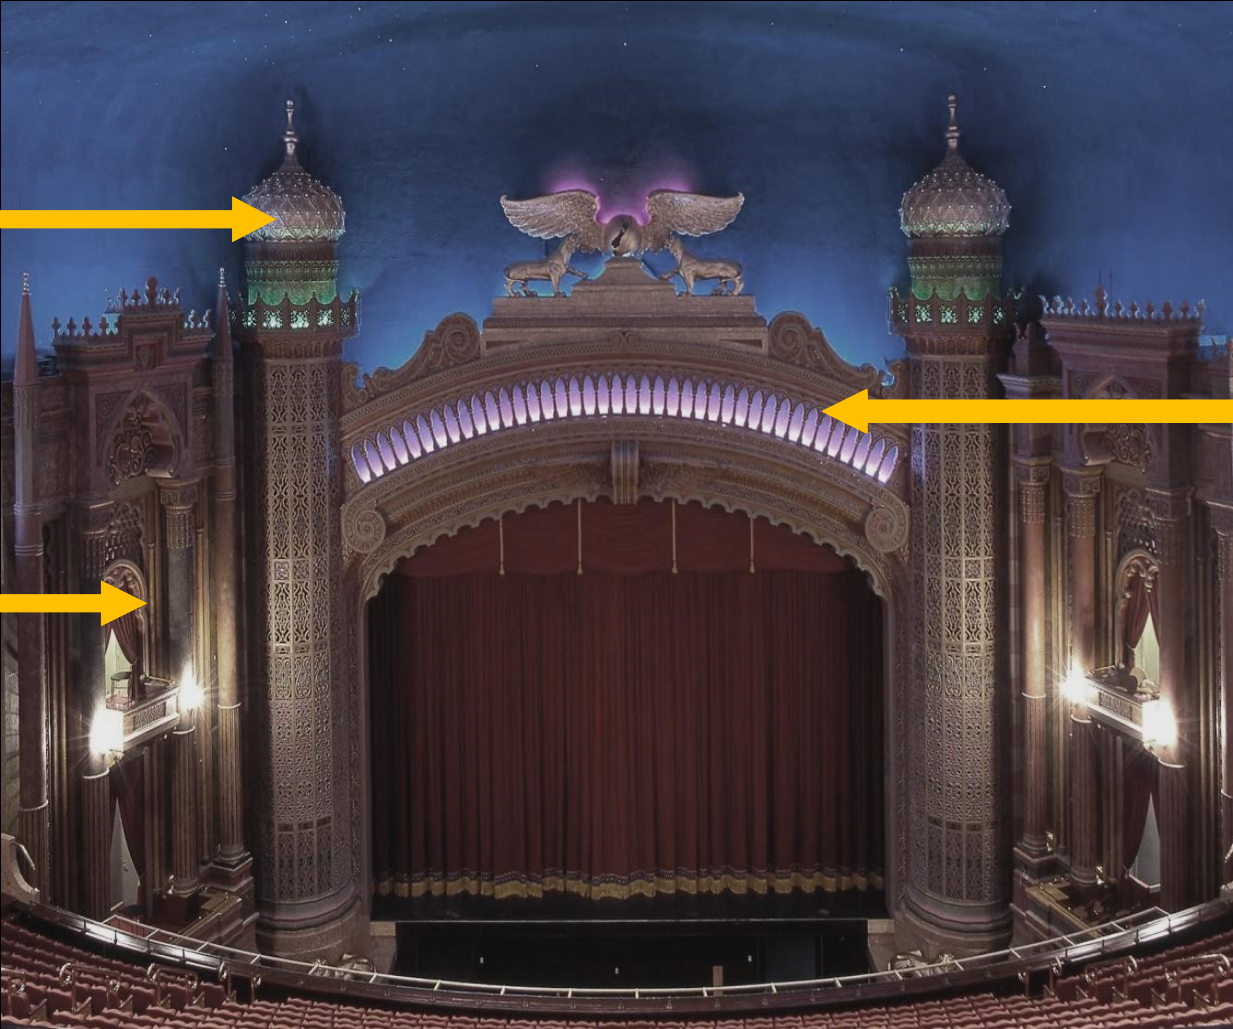
Minaret Tower

Opera Box (15 tonne)

Proscenium Arch (8.5 tonne)

All to be raised two metres to suit new Theatre configuration

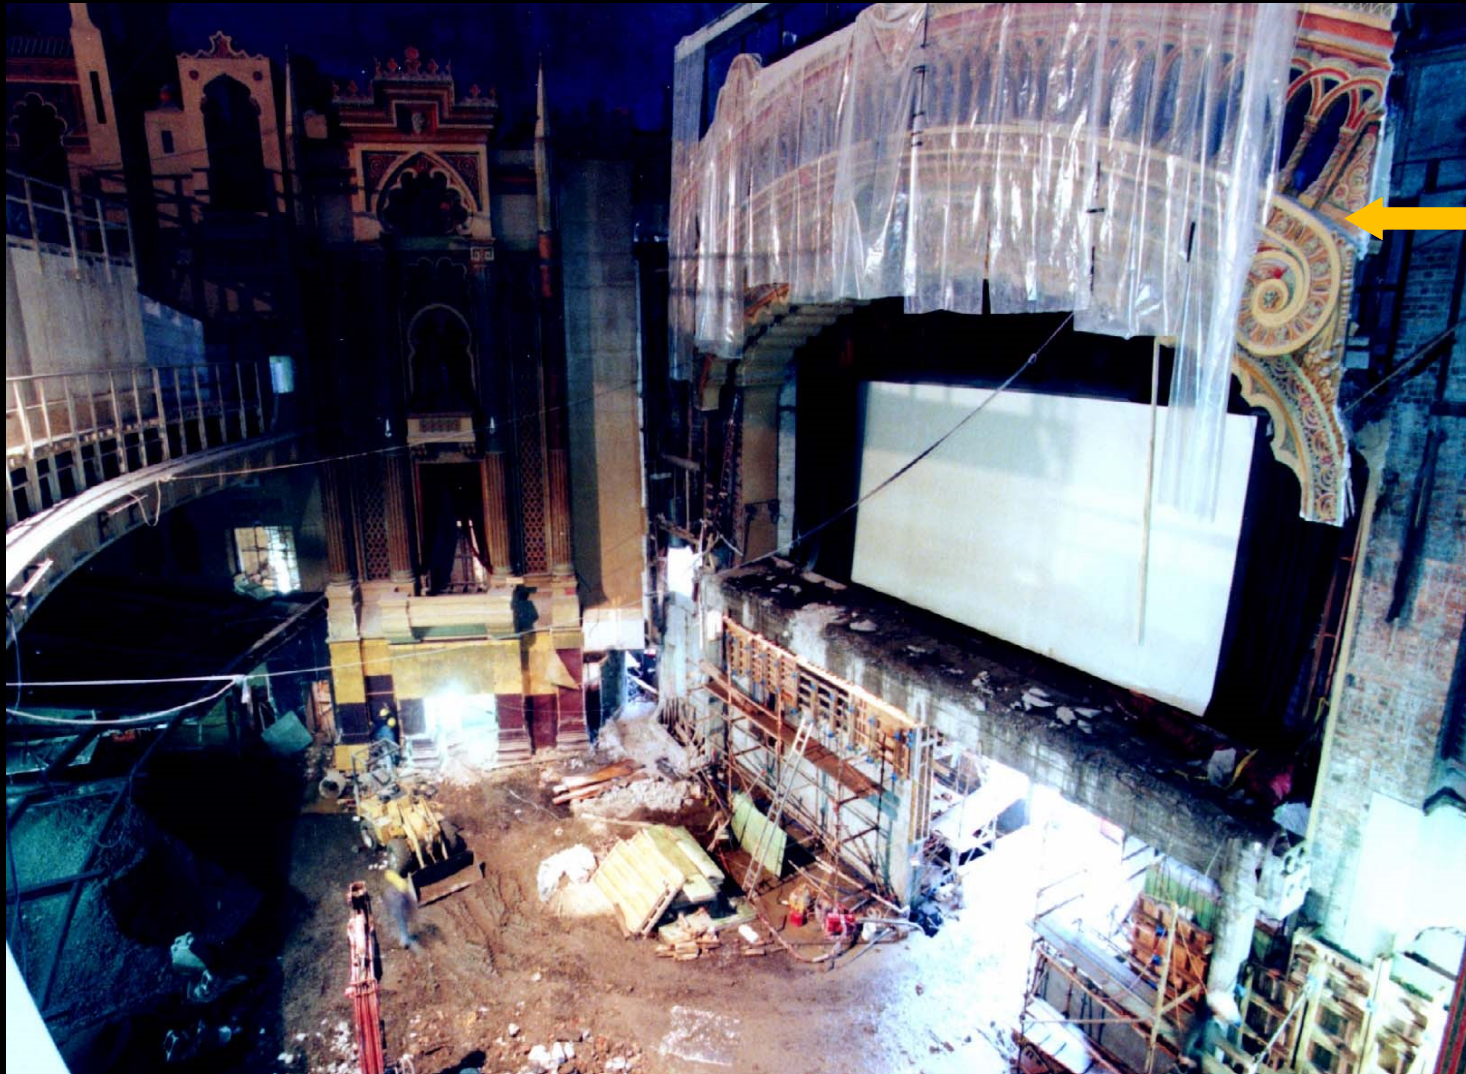
*Proscenium
Arch*

*Detached...
Raised 2m
then
re-attached
to new
concrete
wall*

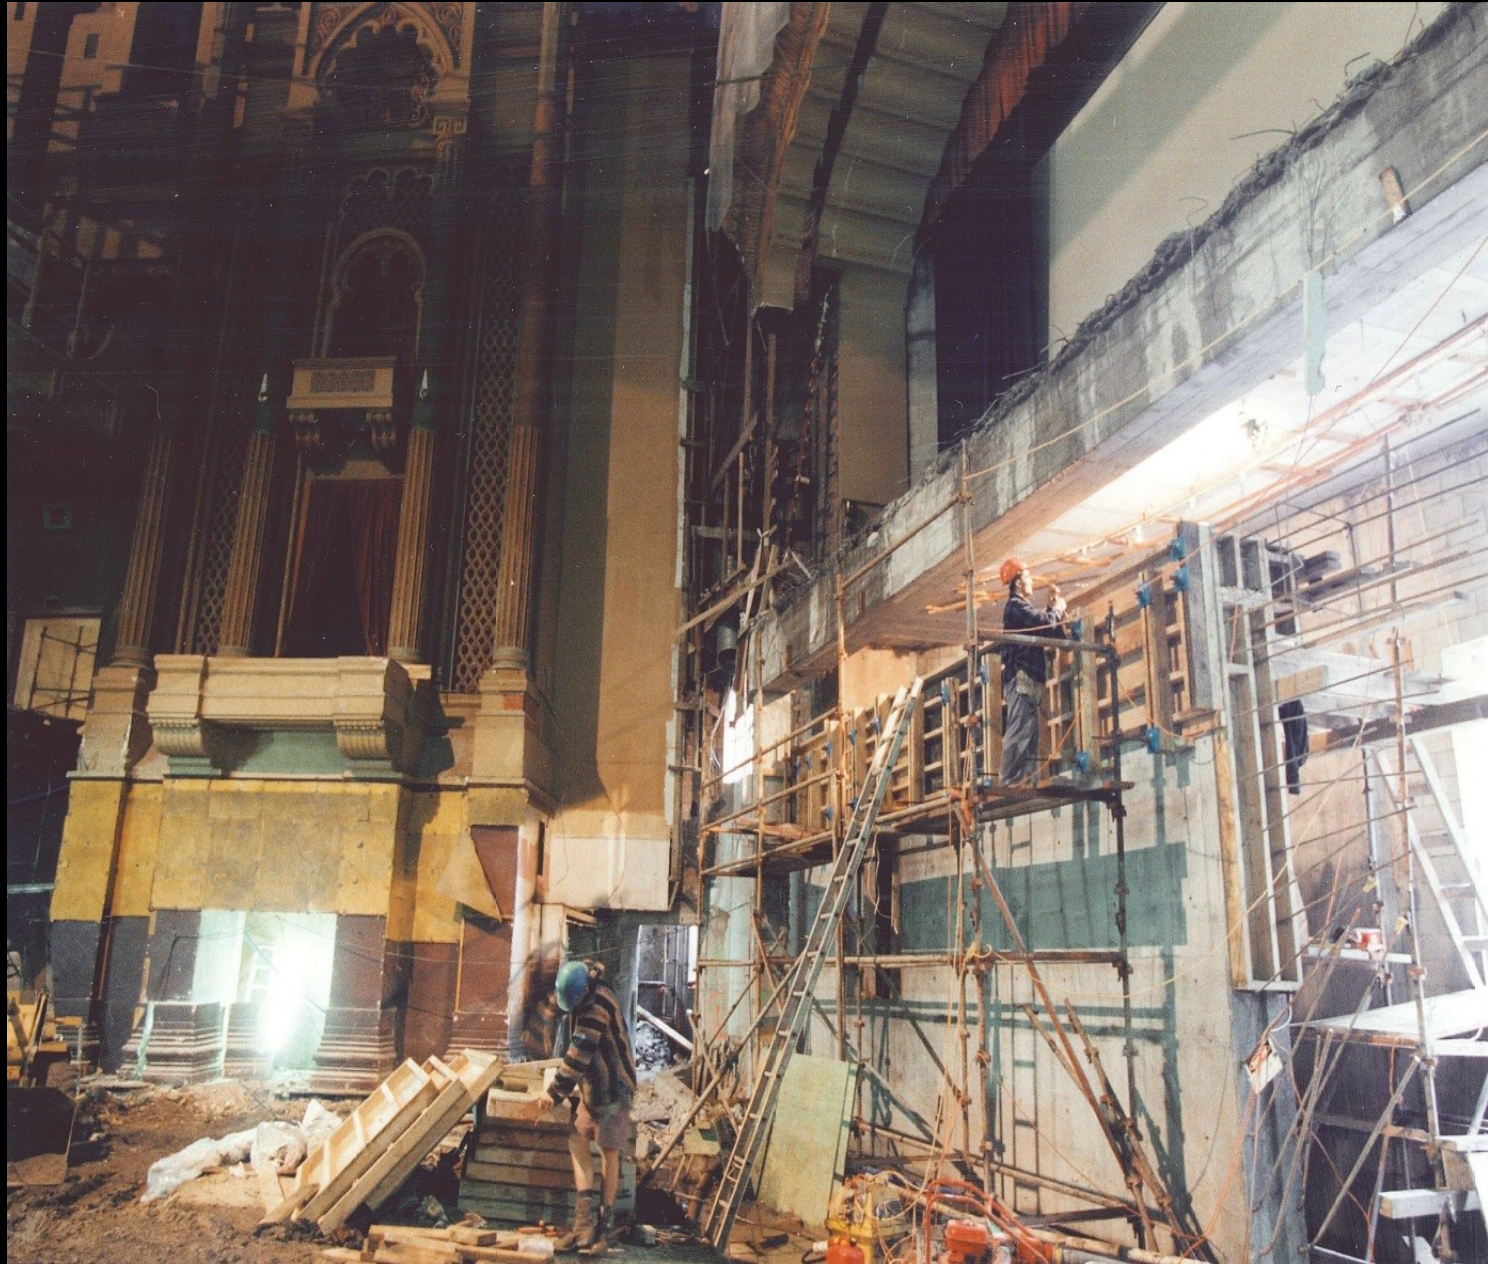
Opera Boxes

*To be raised
up 2 metres*

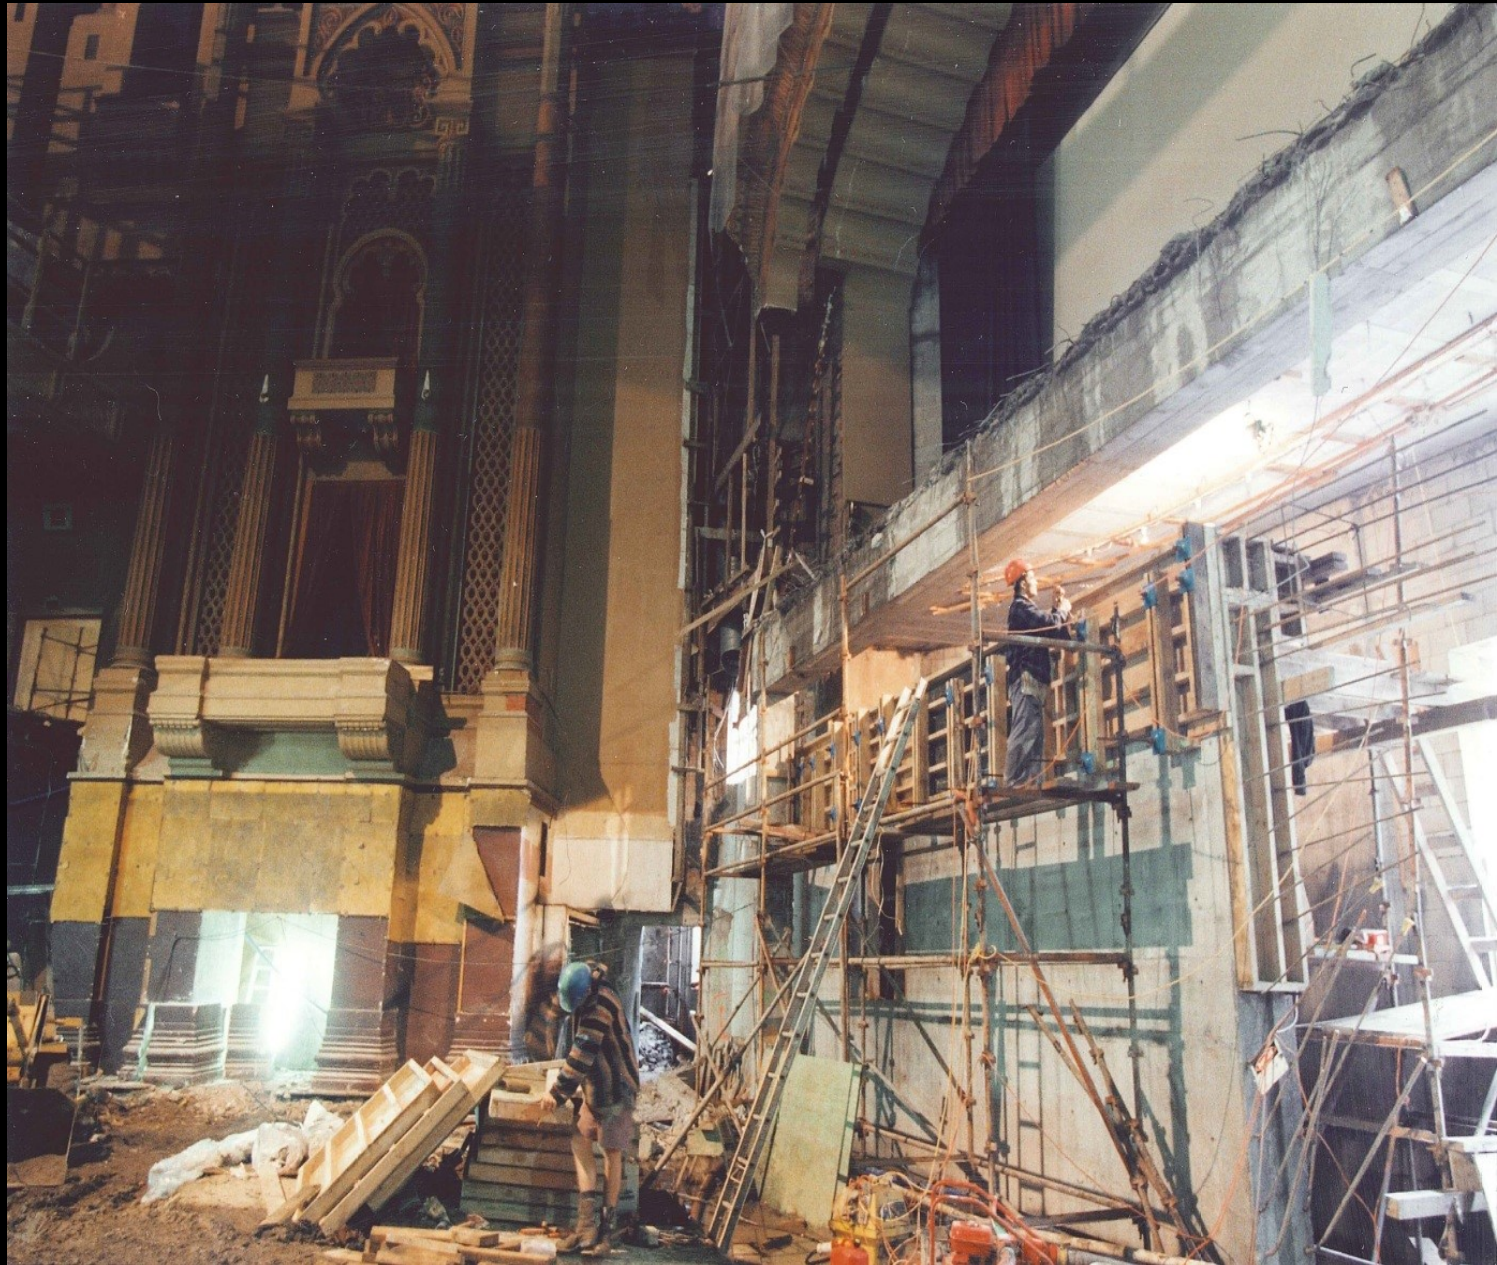
Opera Boxes

*To be raised
up 2 metres*

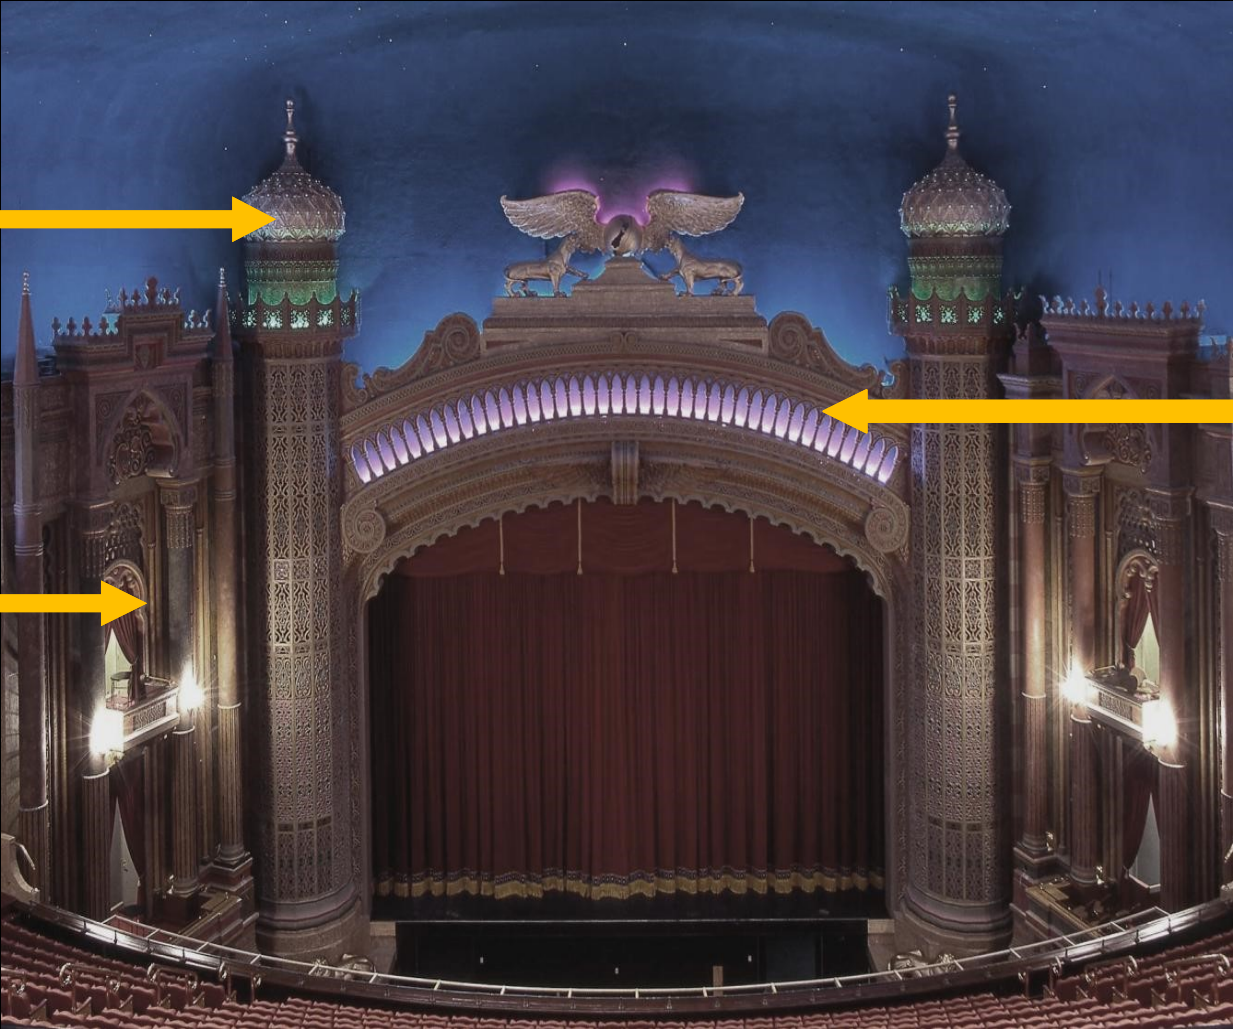
*Minaret
Tower*

*Opera
Box
(15 tonne)*

*Proscenium
Arch
(8.5 tonne)*

*All to be
raised two
metres to
suit new
Theatre
configuration*

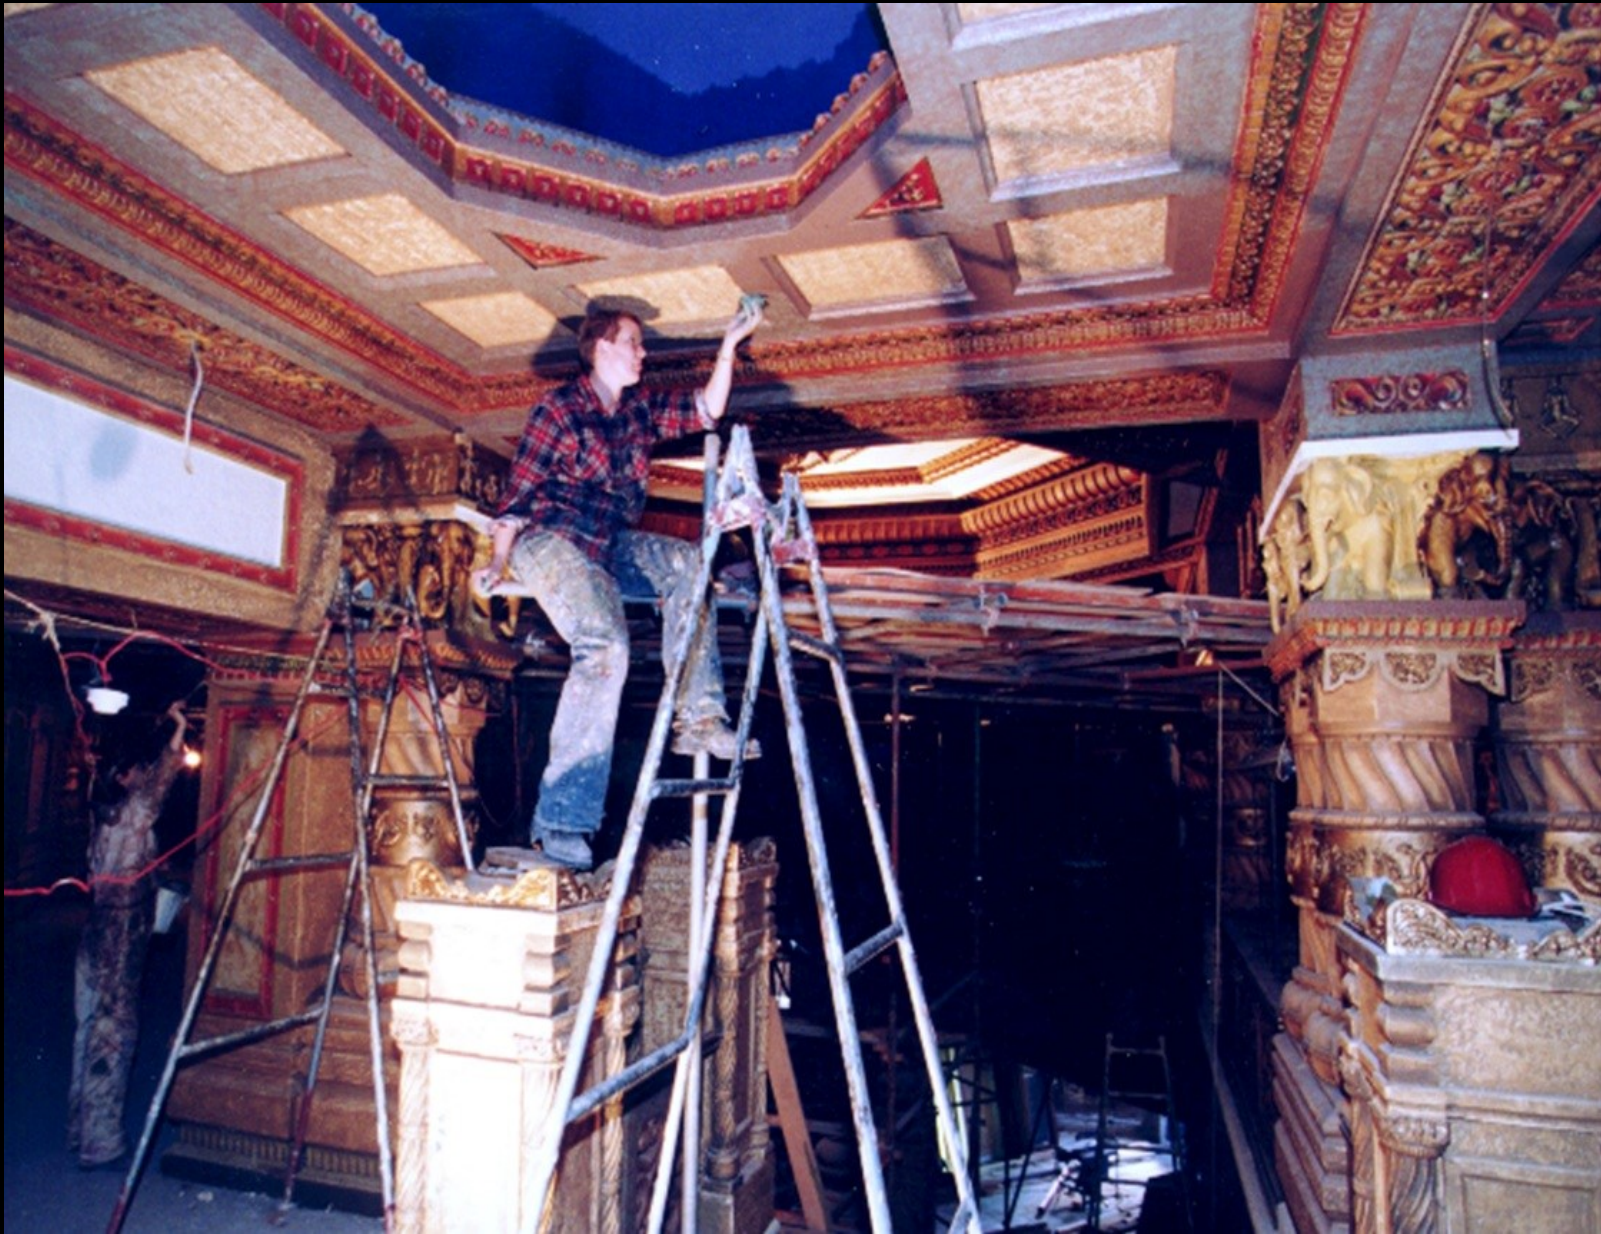
*Plastering
& Painting*
